CR 91.006

April 1991

## Contract Report

## CAST COIL TRANSFORMER FIRE SUSCEPTIBILITY AND RELIABILITY STUDY

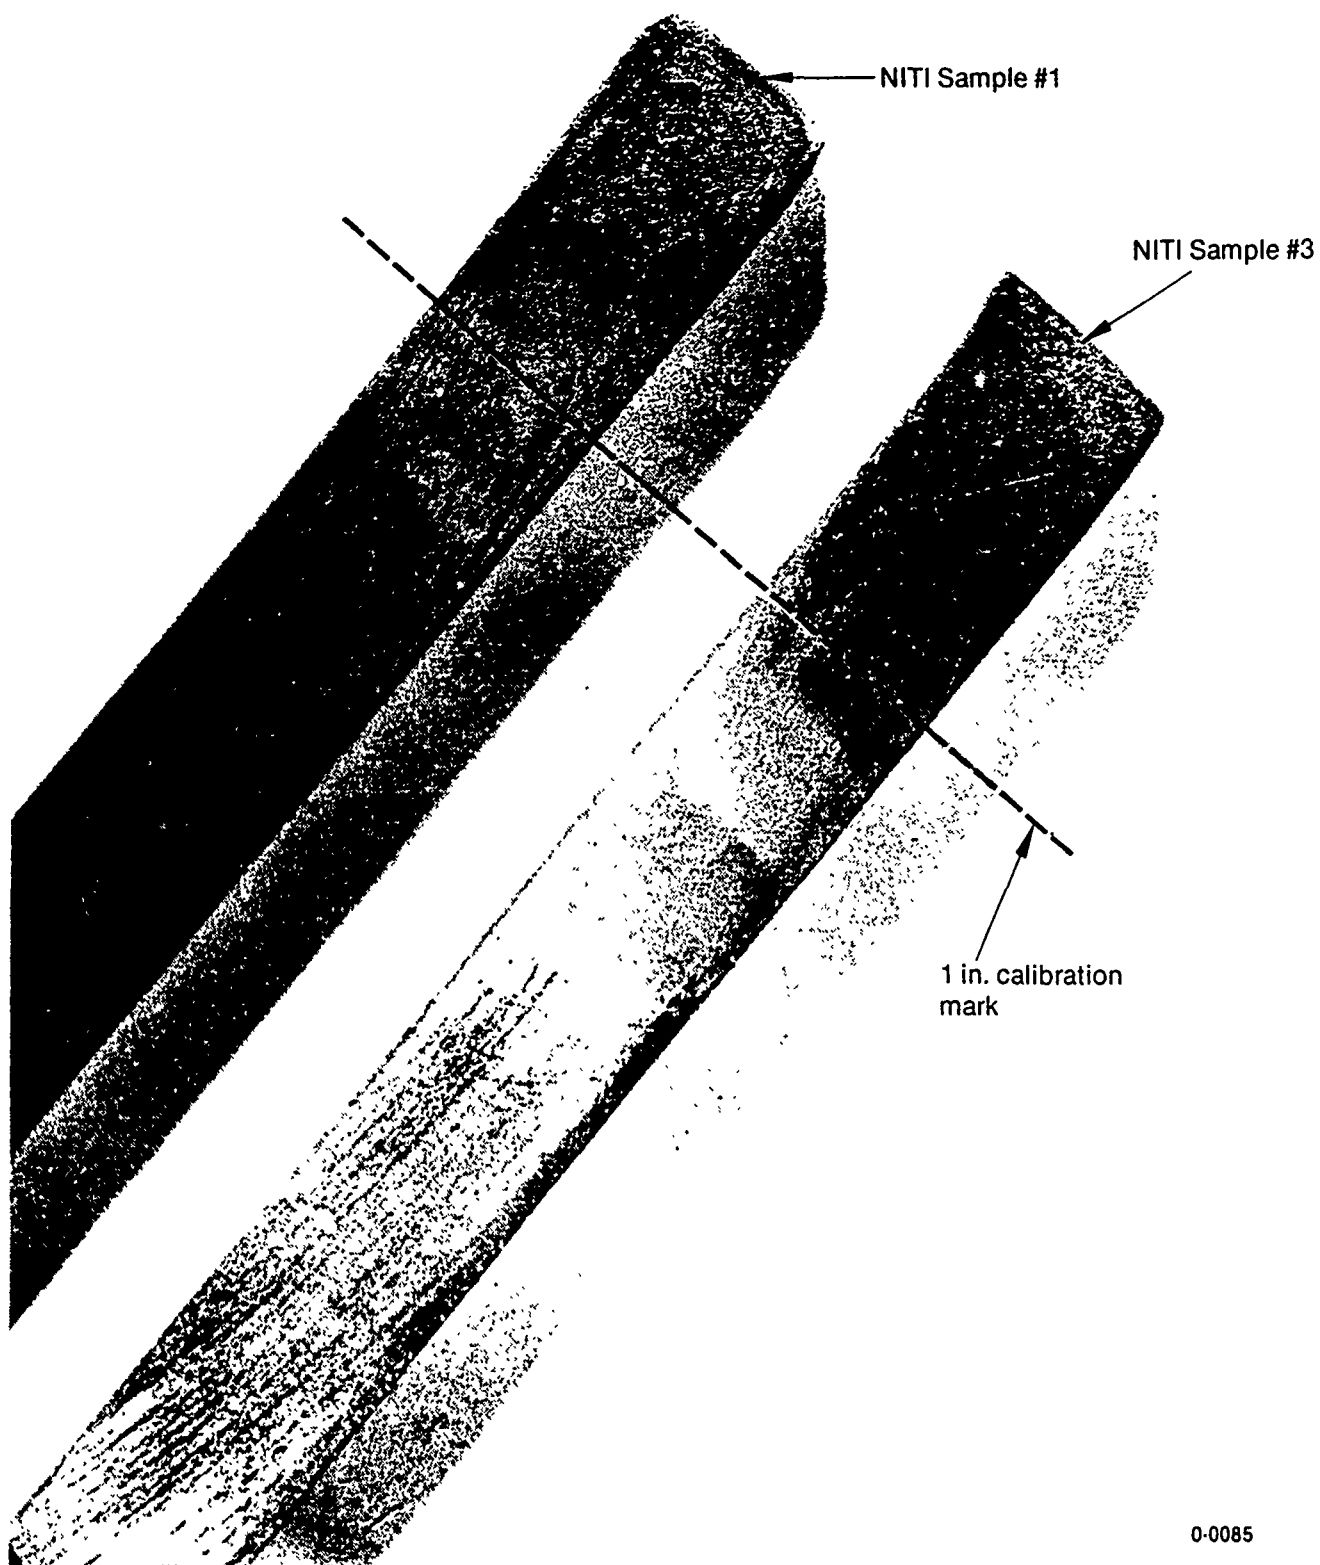
0-0085

**Figure C-2.** This photograph is of two silica-filled BPA epoxy samples (National Industri Transformer, Inc.) that have been subjected to the burn tests. The flames caused a minimum amount of degradation of the material. In comparison to Figure C-1 the filled sample was less effected than the unfilled sample. This material also proved to be nonburning by the definition of the test procedure.
